Figure 2-2. Summary Events Chart and Accident Chronology

2.2 HAZARDS, CONTROLS, AND MANAGEMENT SYSTEMS

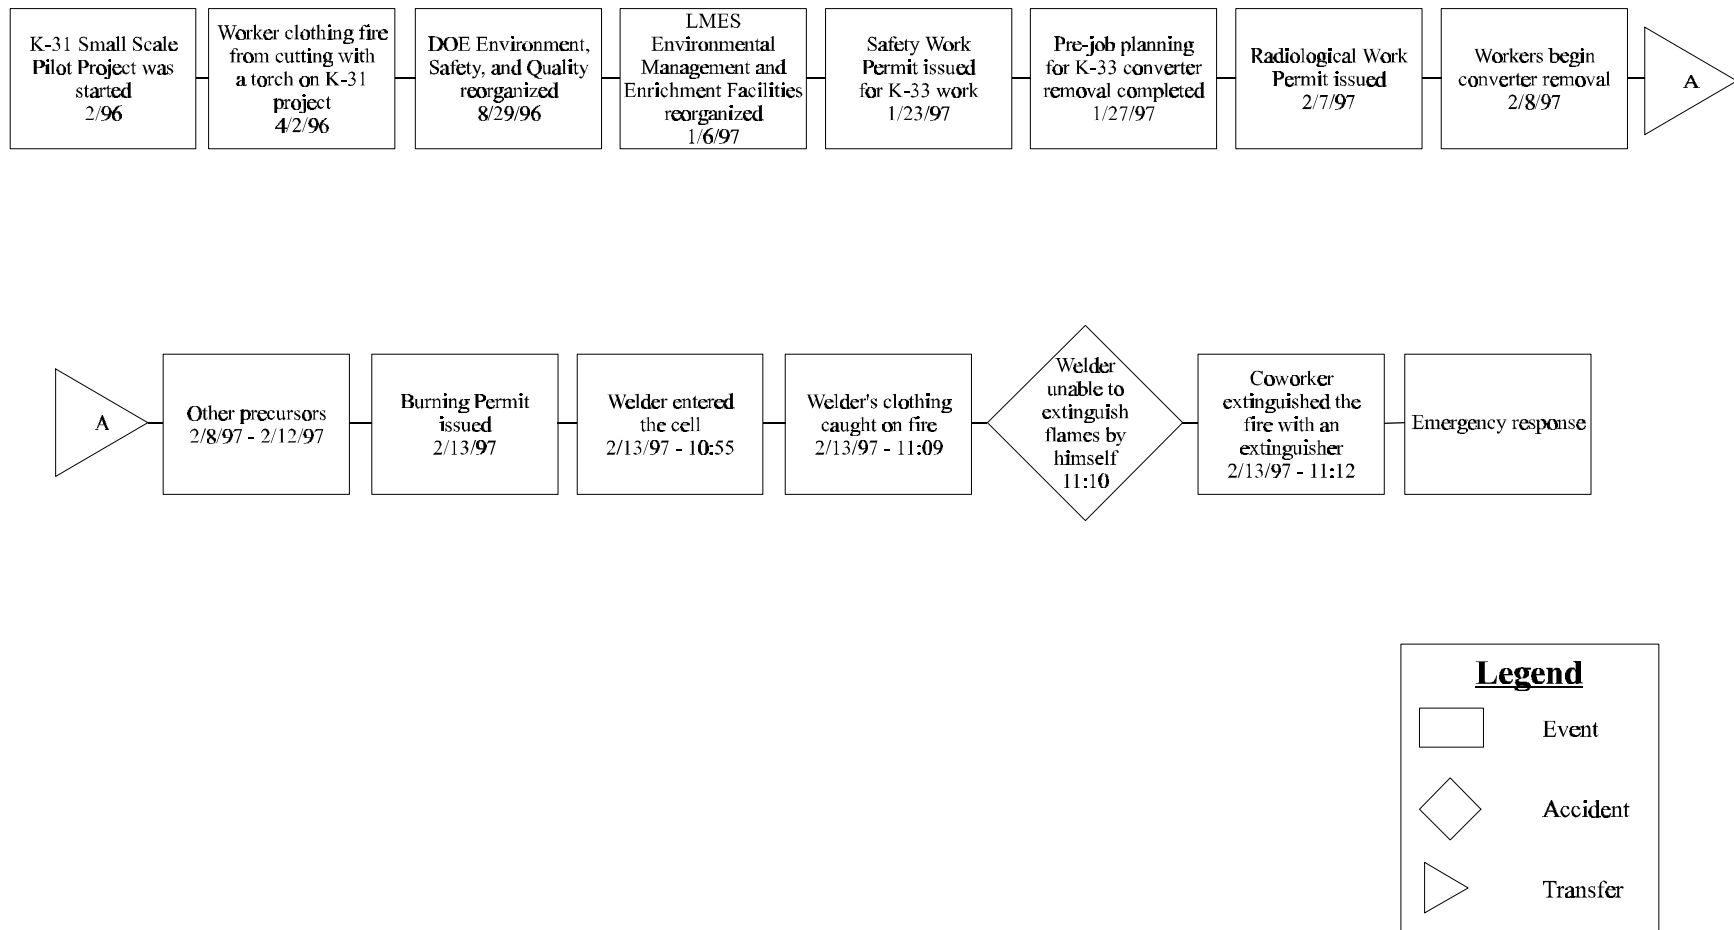
The Welder was burned over 95 percent of his body. He died the next day.

The overall quality of the accident response effort on February 13, 1997, was satisfactory and provided the Welder opportunity for survival, if his burn wounds had not been so extensive. However, egress from Cell 7 was problematic because of poor illumination and the confined nature of the work site. The difficult extraction from the cell/building accounted for delay in transport to the Medical Center. Twenty minutes of the rescue time were spent getting patient-removal gear to Cell 7 and maneuvering the stretcher-borne, 215-pound Welder over and under pipes. A nearby cell panel opening also had to be enlarged for egress. Without the obstacles, the egress difficulties from Cell 7, the physical distances involved, and the lack of basic first-aid gear in the building, the extraction time could have been shortened by approximately ten minutes.
